Failure analysis of SMS-1 EOT crane hoist C-hook

J. N. Mohapatra^{1*}, Sujata Panda¹, G. Praveen Kumar² and D. Satish Kumar¹¹Department of R&D, JSW Steel Ltd., Vijaynagar Works, Bellary, Karnataka, India²Department of SMS-I, JSW Steel Ltd., Vijaynagar Works, Bellary, Karnataka, India***Correspondence:**J. N. Mohapatra,
jitendra.mohapatra@jsw.in**Received:** 01 November 2025; **Accepted:** 27 December 2025; **Published:** 12 January 2026

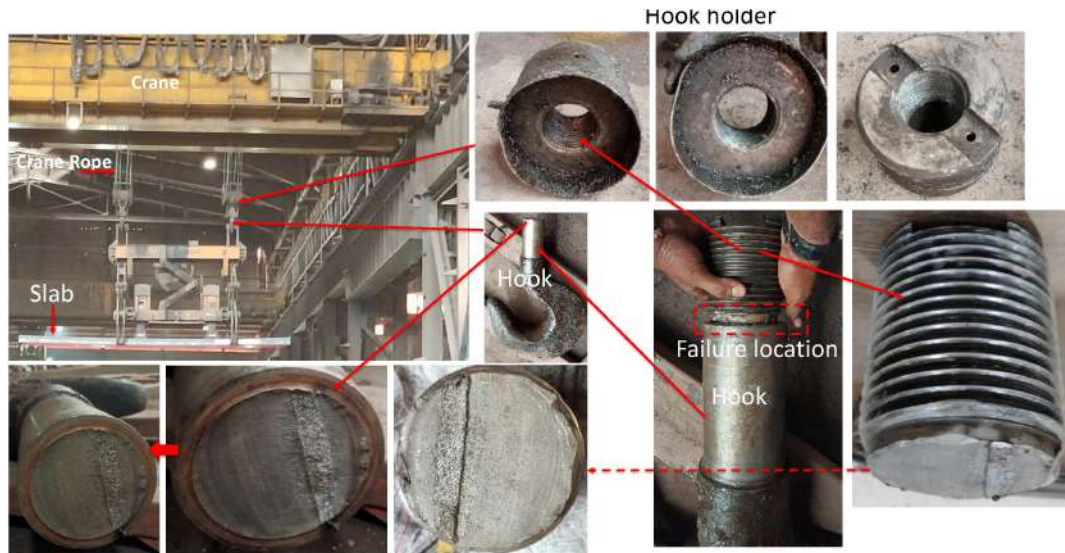
FIGURE 2 | Visual examination of the EOT crane hook showing failure at a thread groove region.

As shown in **Figure 2**, the EOT crane has the assembly of two hooks with ropes to carry the hot slabs. The hook has failed at the thread groove region marked

by red dashed lines. The fracture surface of the hook from the hook side and from the holder side is shown in **Figure 3**. Fatigue striations/beach marks are found from both sides of the hook, with the final failure at the central part.

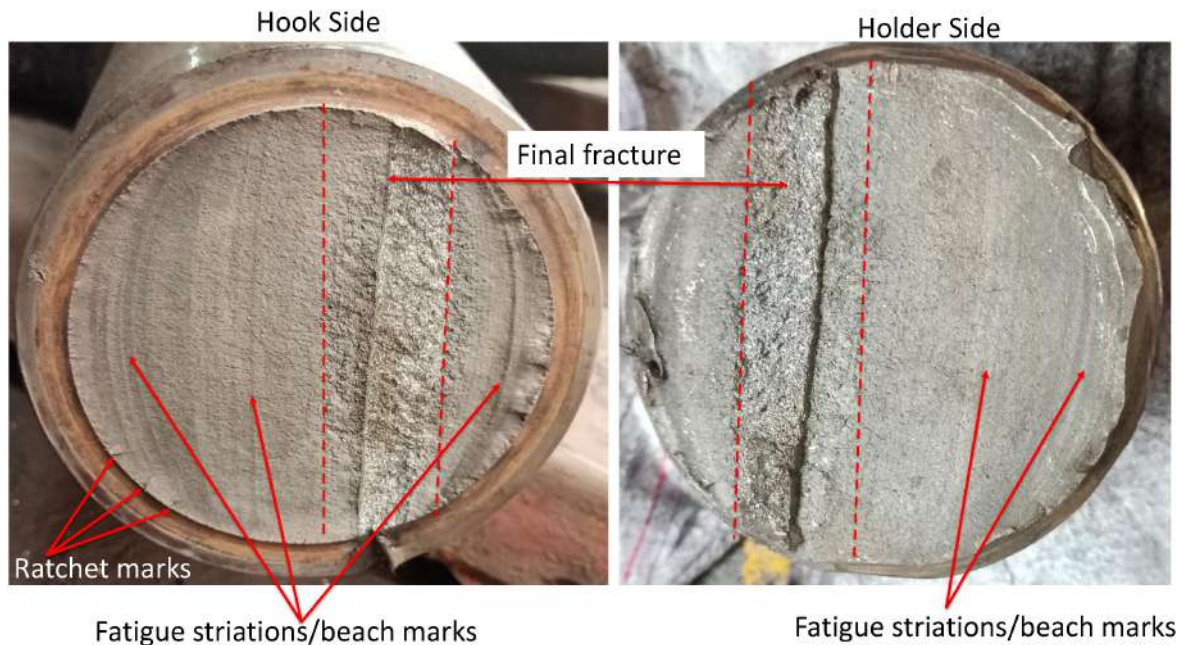
FIGURE 3 | Visual examination of fracture surface of hook side and holder side showing fatigue striations from both sides with final failure at the center.

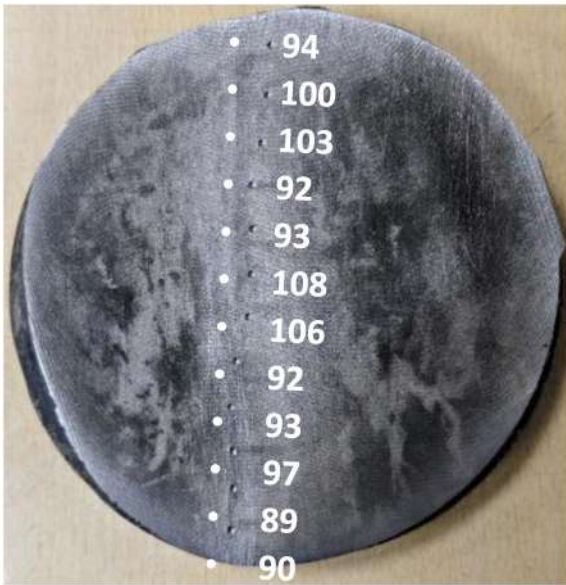
FIGURE 4 | Brinell hardness of the hook shows no systematic variation from surface to core.

Hardness of the shaft in the Brinell scale is shown in **Figure 4**. No systematic variation in hardness is found from surface to core of the shaft, indicating no quench and temper heat treatment or surface hardening treatment was made on the hook. The hardness is found to be in the range of 90–108 BHN (<382 MPa UTS), which is lower than the specification of >110 BHN (402 MPa UTS) (1 A: IS1785:1992). Such hardness might have decreased in service due to exposure to high temperatures up to 600°C. A lower hardness leads to lower ultimate tensile strength and lower fatigue strength of the hook. Hence, hardness should be as per specification for the safe use of the hook to withstand the desired load in operation. The fatigue strength of steel is approximately half of its ultimate tensile strength, and hence, lower ultimate tensile strength leads to lower fatigue strength of the hook.

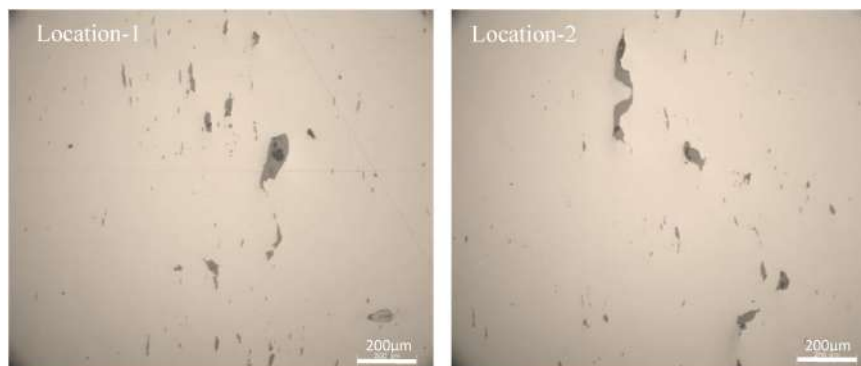
FIGURE 5 | Inclusion analysis—lot of MnS and silicate inclusions are found.

Although a lot of locations were analyzed for inclusion analysis. Two representative regions (location-1 and location-2) are shown in **Figure 5**. A lot of manganese sulfide, silicate, and globular oxides are found on the shaft. The inclusion rating as per the worst field method (ASTME-45) is shown in **Table 3**. Such large-size inclusions are not acceptable for dynamic loading engineering components such as shaft, as inclusions act as the nucleation site for fatigue crack initiation. At the inclusion sites, stress concentration increases, which eventually lead to the initiation of fatigue crack, which, in long-term service, propagate and result in final fracture.

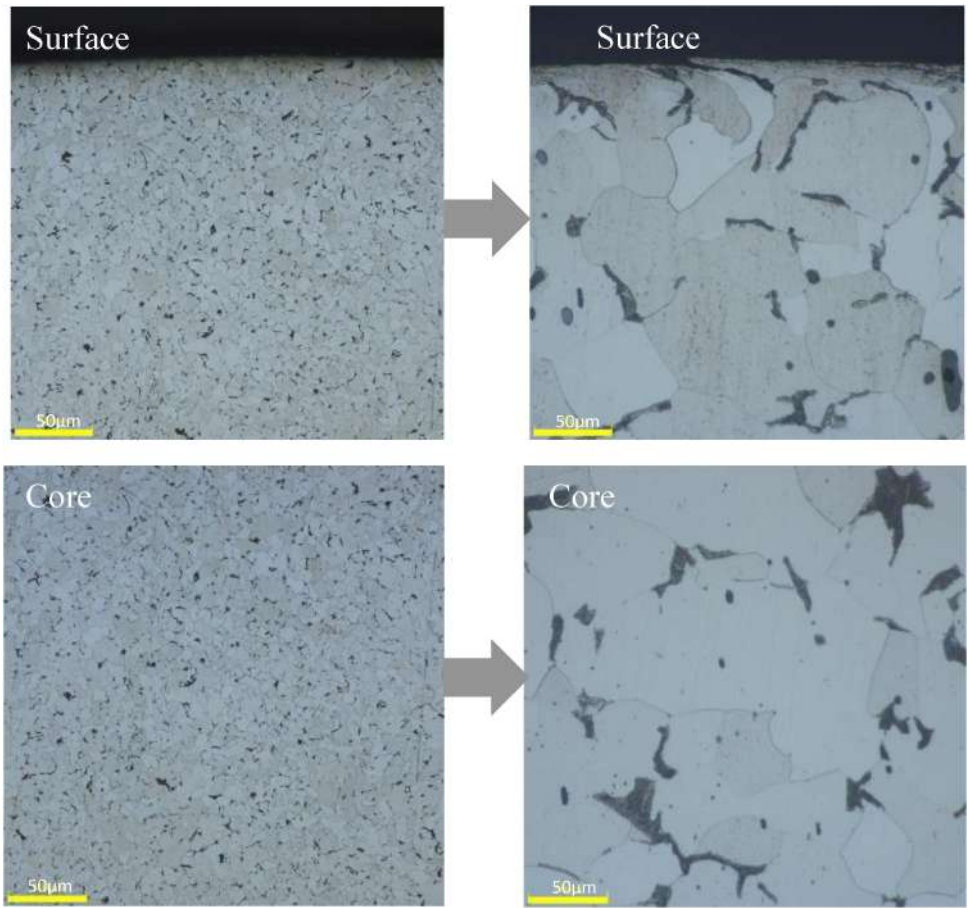
FIGURE 6 | Surface and core microstructure and their high-magnification images.

The microstructure of the hook close to surface, and core is shown in **Figure 6**, and its SEM micrograph is shown in **Figure 7**. It shows ferrite-pearlite microstructure with no variation in microstructure from surface to core, indicating no surface hardening heat treatment was made on the hook. Grains are found to be coarser in nature. **Figure 8** shows numerous transgranular cracks near to the fracture surface of the hook. No scale has been observed on the hook, although it is exposed to temperatures up to 600°C, which might be due to no direct contact of flame on the hook material.

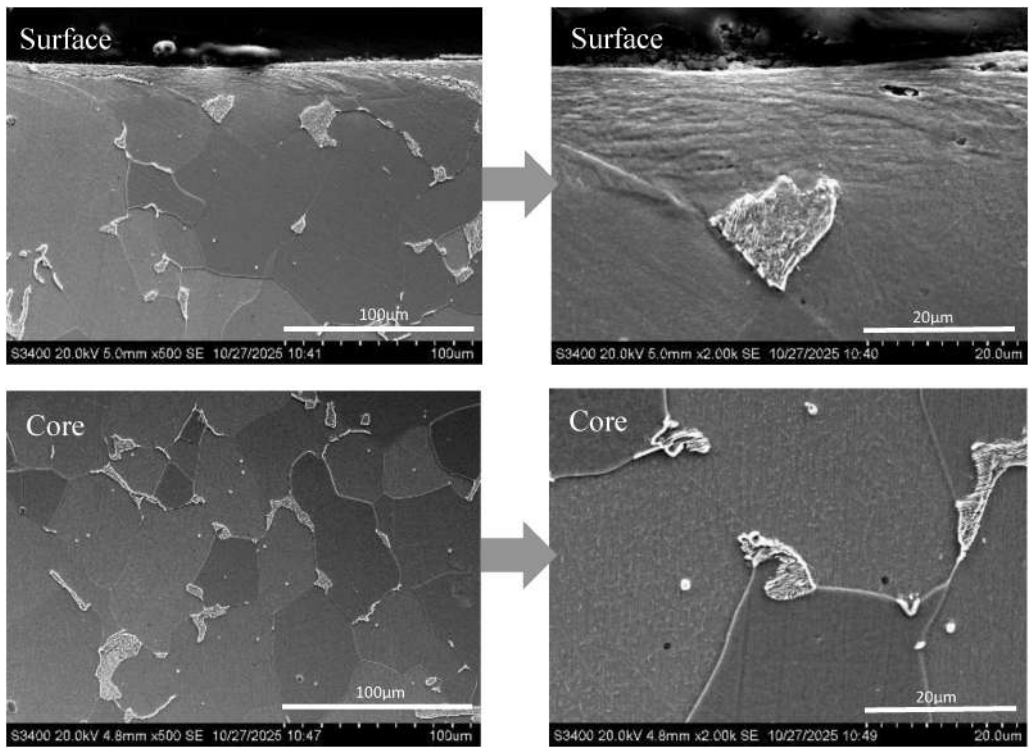
FIGURE 7 | Surface and core micrographs and their high-magnification micrographs.

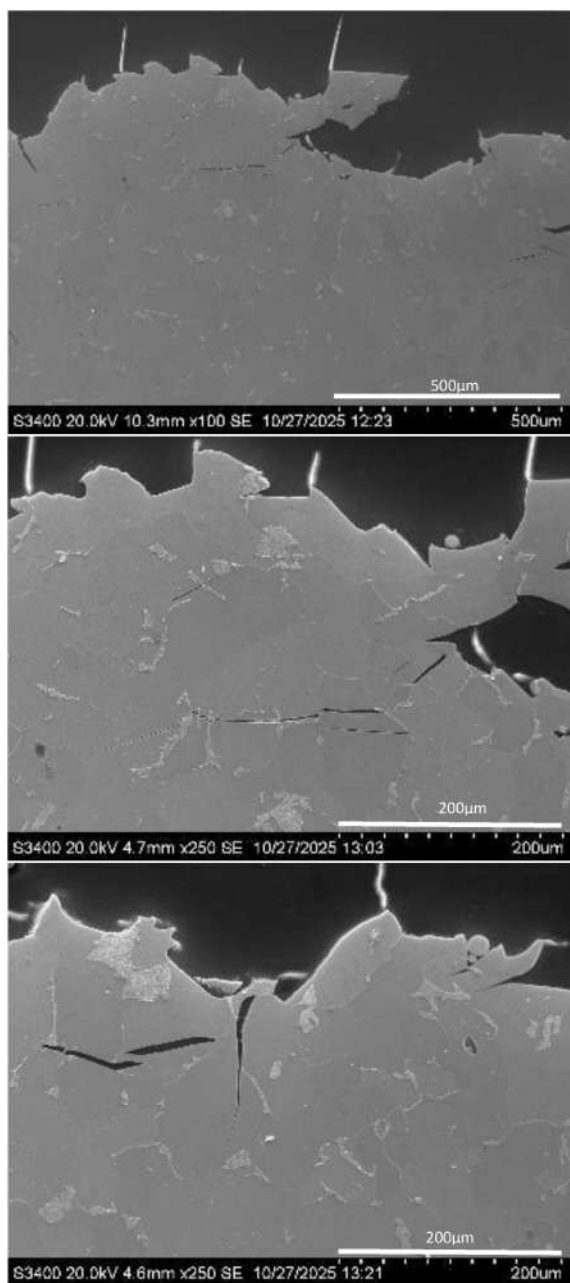
FIGURE 8 | A lot of transgranular cracks were observed near to the fracture in the hook.

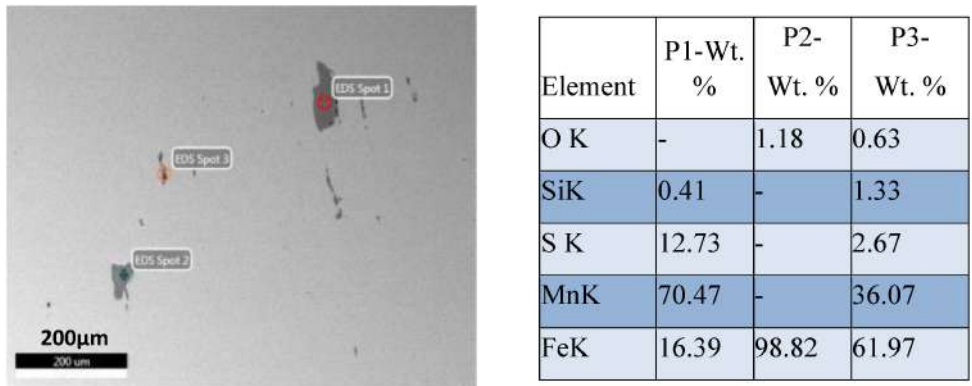
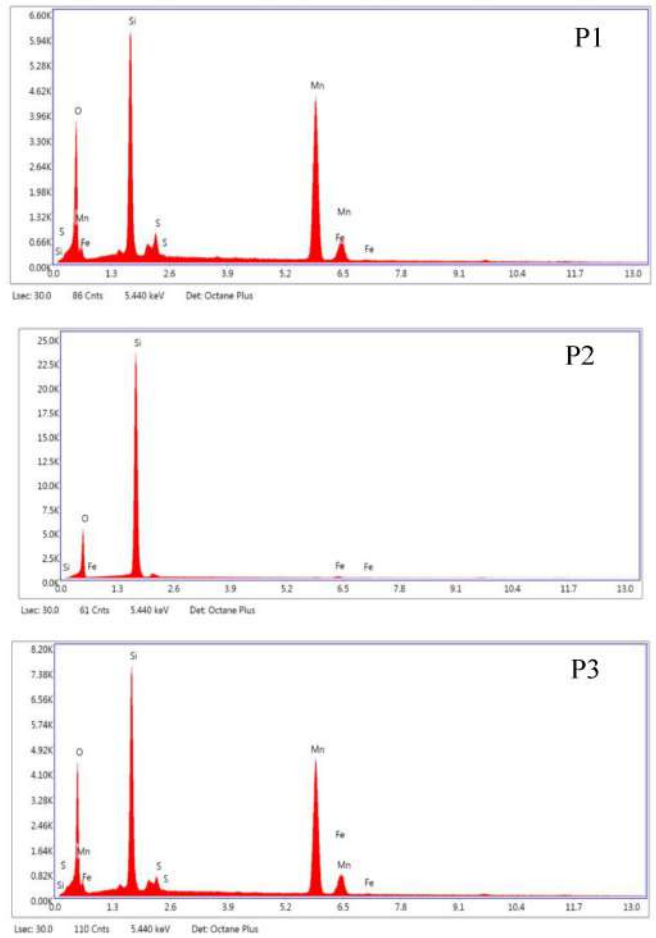
FIGURE 9 | SEM EDS of inclusions revealing MnS and silicates.

A lot of MnS and silicate inclusions are found, as shown in Figure 9. Such inclusions are found in several regions, and hence one representative site is shown in the figure.

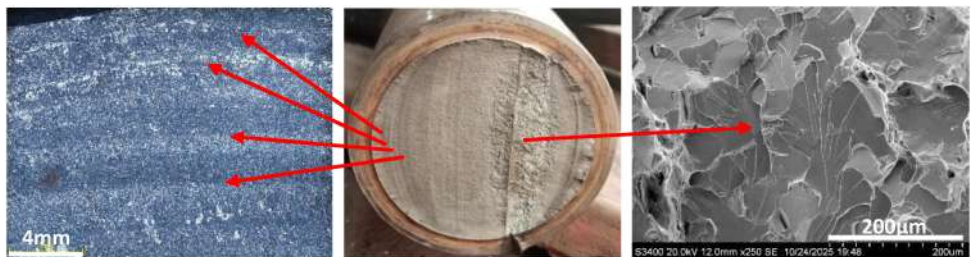
FIGURE 10 | Fatigue striations (left) and final brittle fracture (right) of the hook.

Figure 10 shows the fractography analysis of the crane hook. It can be seen that (left) fatigue striations/beach marks indicate the fatigue failure of the shaft. The fatigue crack

has started at the notch region of the thread groove starting position, which might have been supported by the large-sized MnS or silicate inclusions. The fatigue striations/beach marks are found from both side of the hook diameter, and the final fracture has occurred at the center of the hook diameter. A very similar failure is reported by Das et al. (1). The final fracture occurred in a rapid brittle mode when the cross-section of the hook decreased drastically. **Figure 11** shows the presence of MnS and silicate inclusions on the fracture surface of the crane hook.

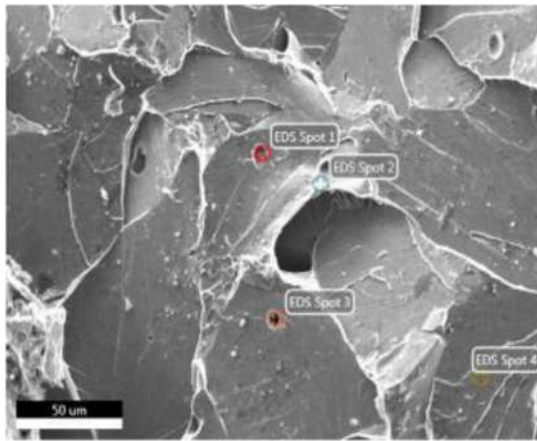
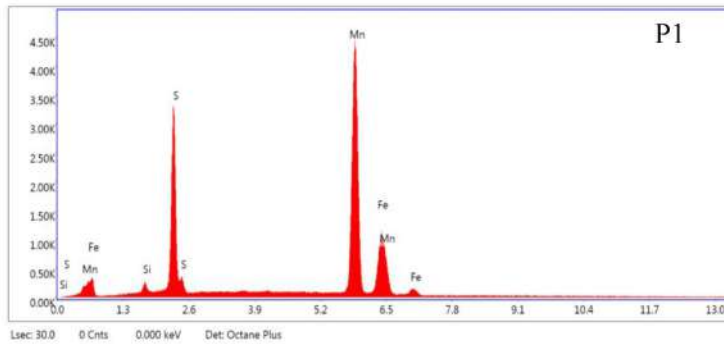
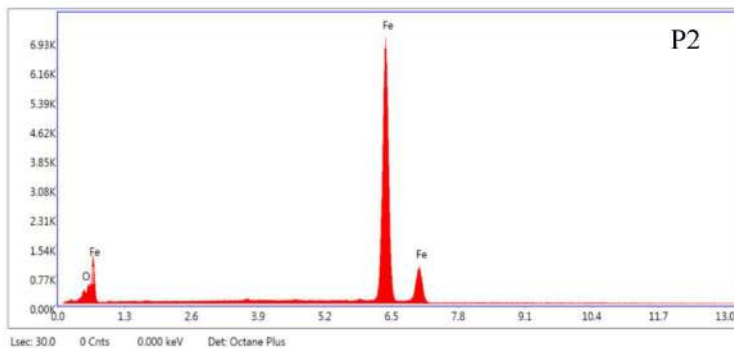
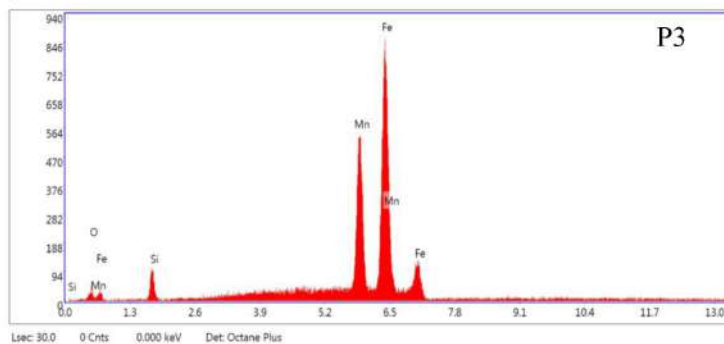
FIGURE 11 | SEM-EDS on the fracture surface showing MnS and silicate inclusions.
